Selecting Stainless Steel for Optimum Performance

Sponsor:
International Molybdenum
Association (IMOA)

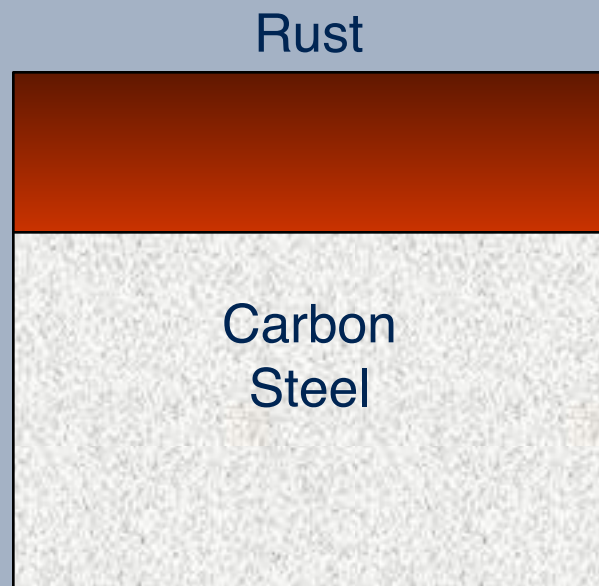
Stainless steel is iron plus at least 11% chromium. If enough chromium is added, a protective passive film will form.

< 11% Chromium

> 11% Chromium

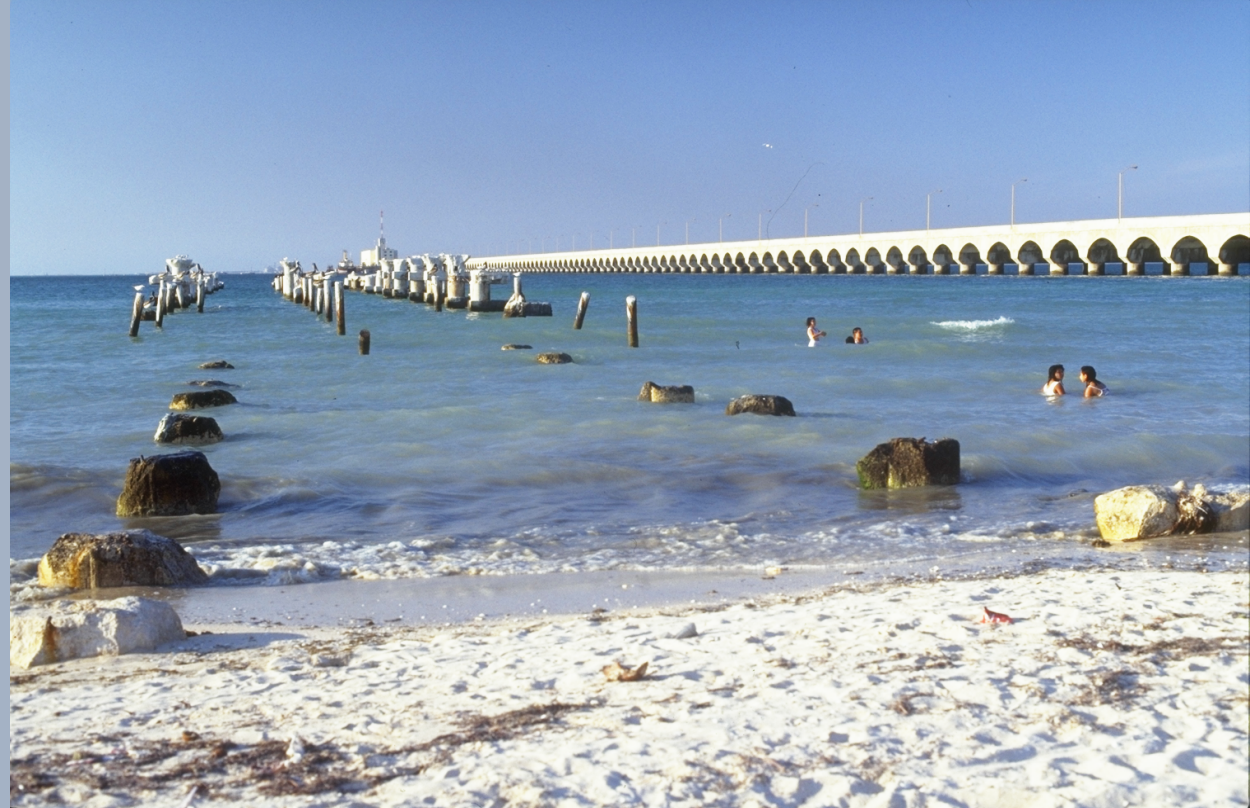
Two Piers, Progreso, Mexico

- Functioning pier
 - Built about 60 years ago (1937-1941)
 - Stainless rebar
- Non-functioning pier
 - Built about 30 years ago
 - Carbon steel rebar

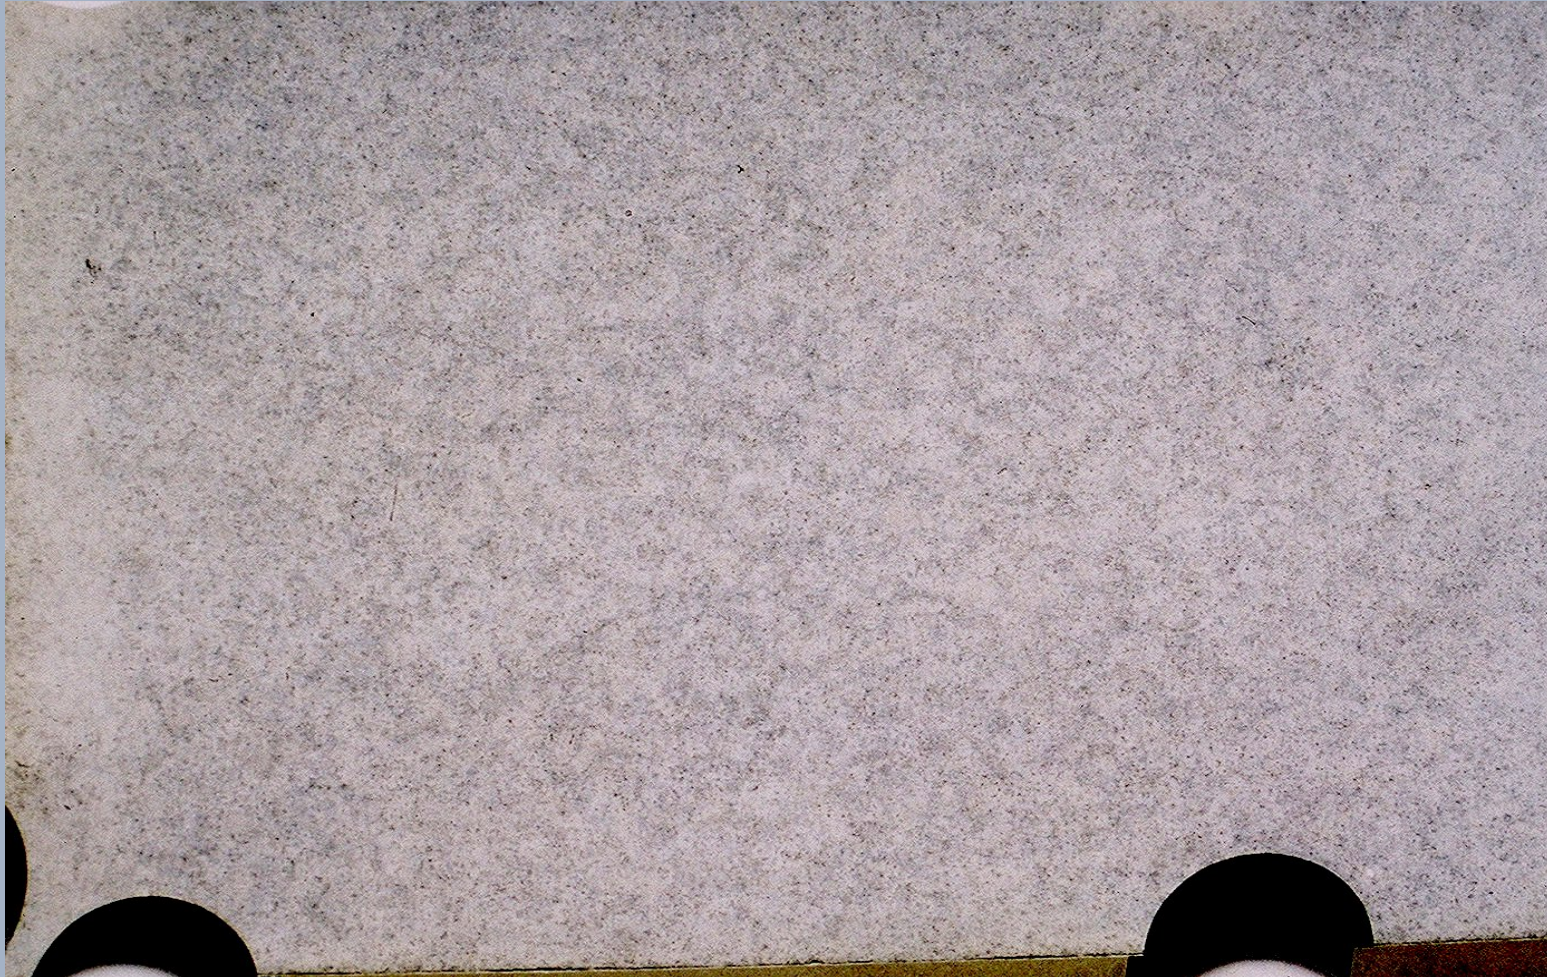
Kure Beach, 58 years

Anodized aluminum, 250 m (800 ft) from the ocean

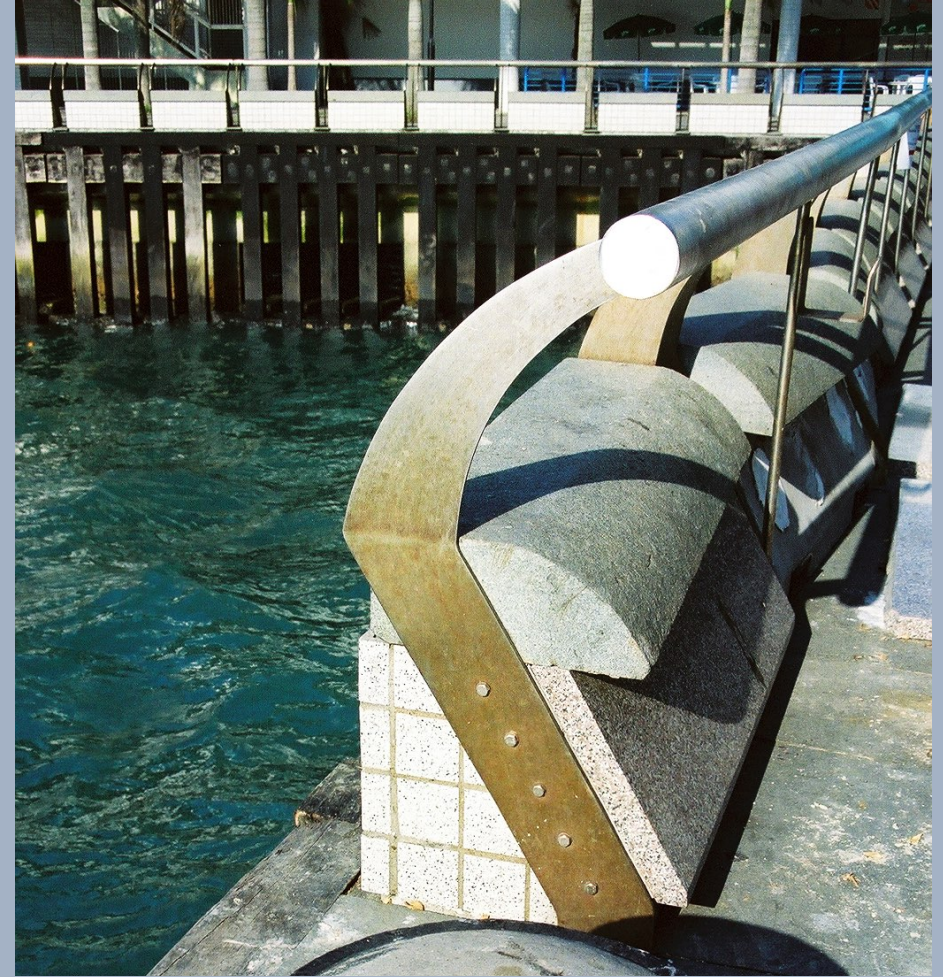
Type 316 railings
Hong Kong Convention Center -
seawater spray exposure, rough finish

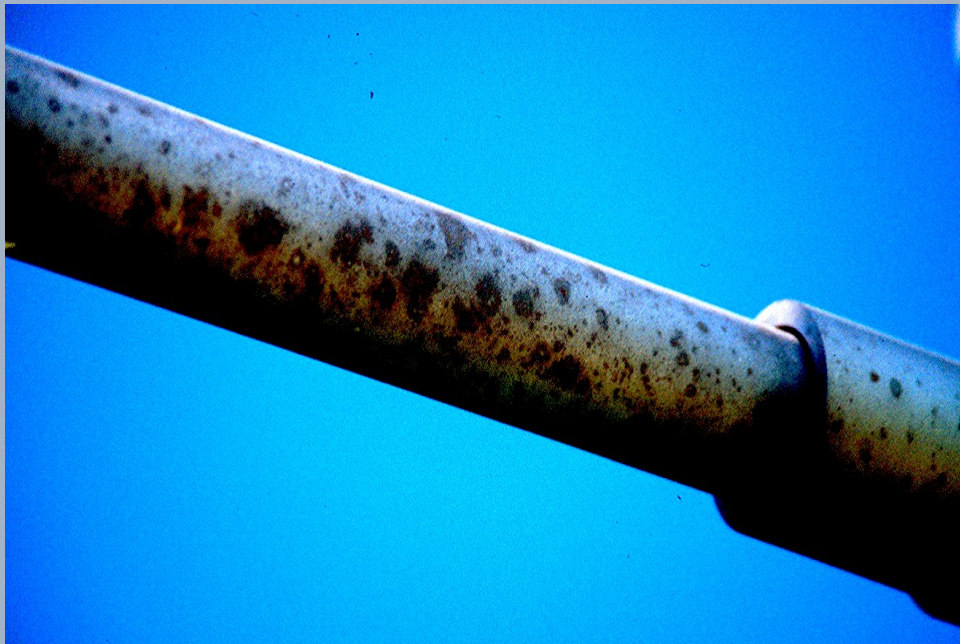
Type 304 Stainless Steel Arbor

- Deicing salt exposure
- Rough, sand blasted finish
- Sculpture park
- Minneapolis, USA

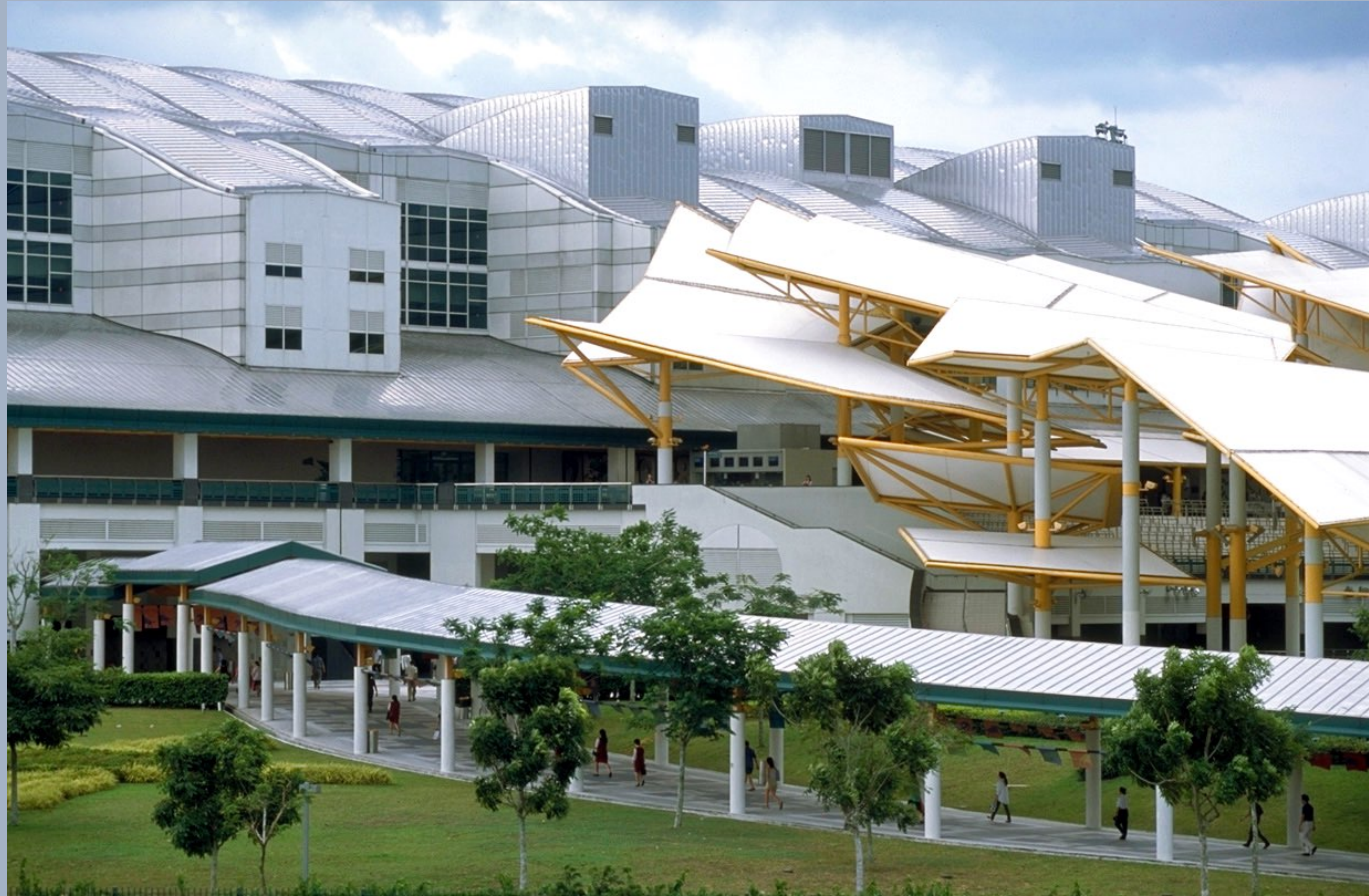
Singapore Turf Club

Type 316 roof
2D finish

Curved 400 meter
long building and
walkway canopies

Standing seam roof

Modular design kept
costs down

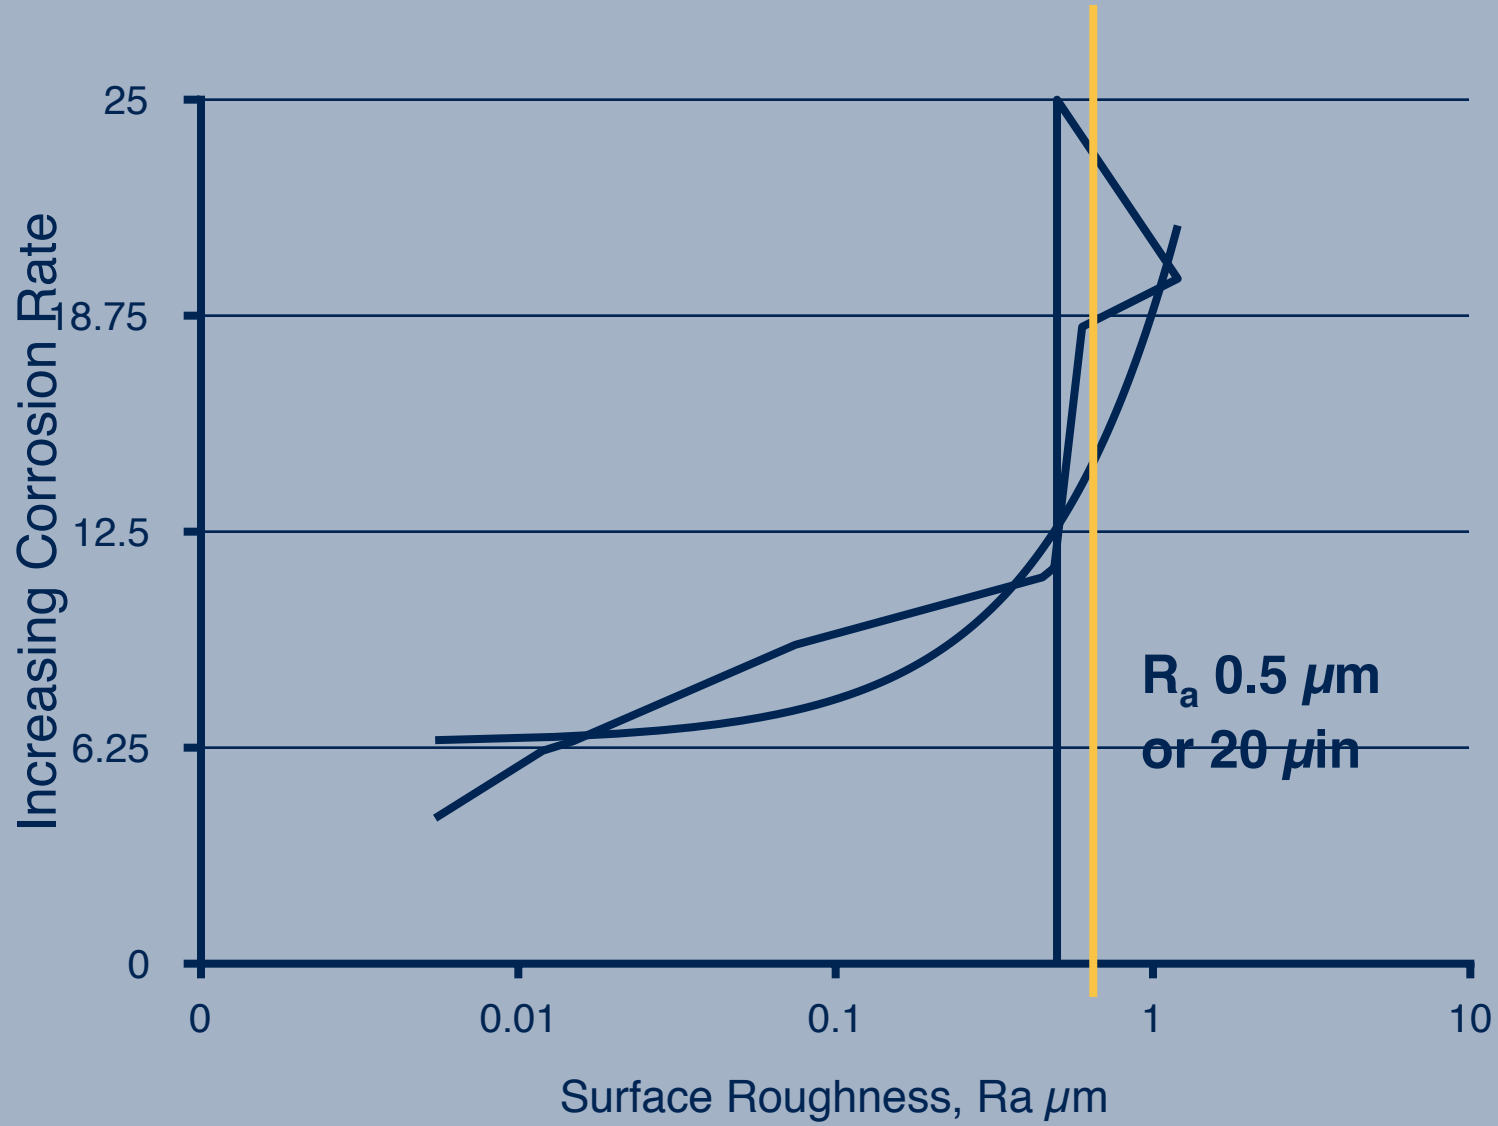
Type 316 railings beside a beach

Specifying the surface roughness is as important as selecting the right stainless steel.

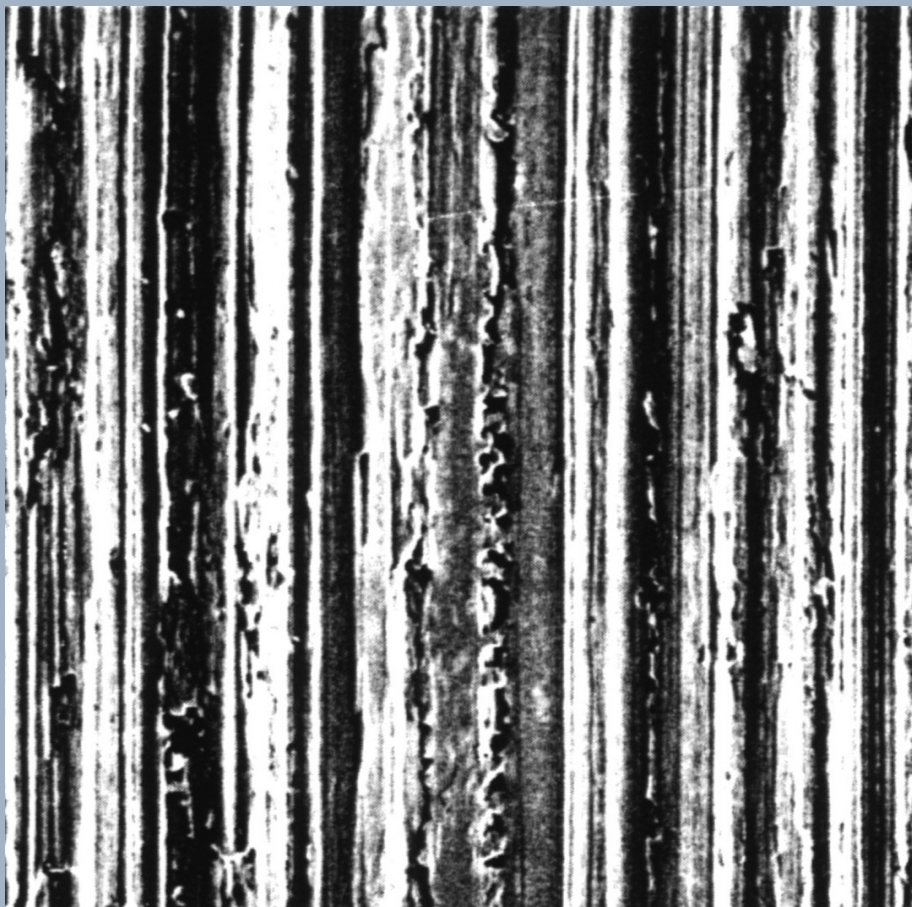
No. 4 Finish Aluminum Oxide

R_a 0.7 μm (28 μin)

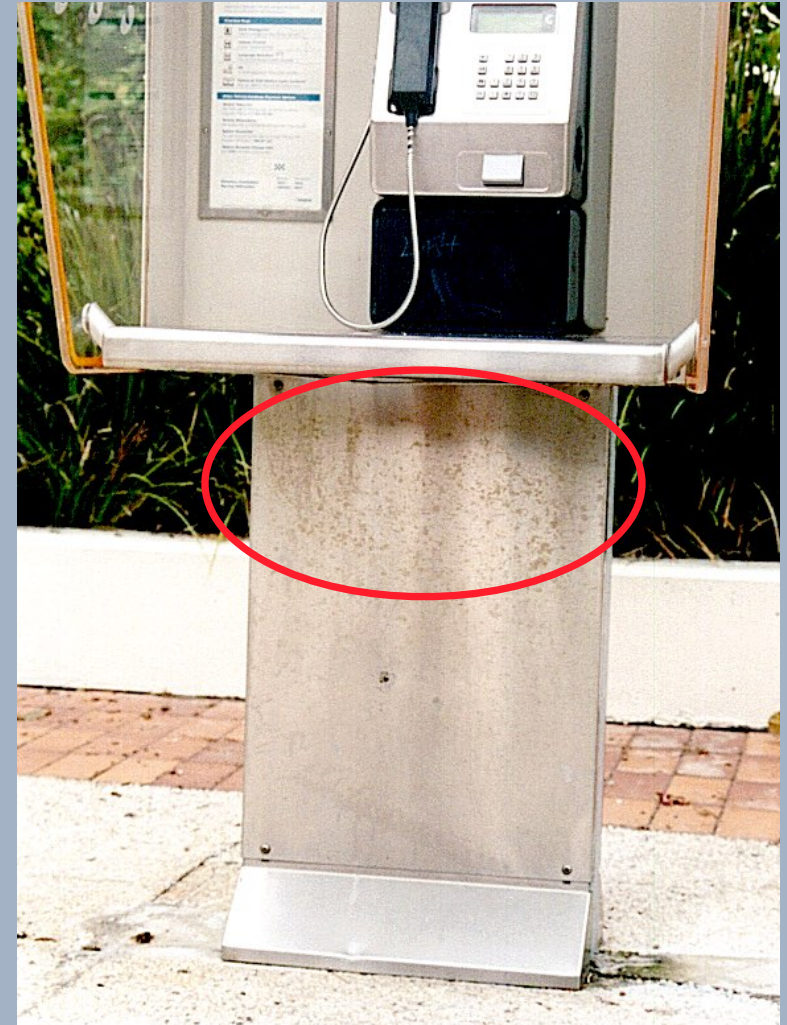
Sheltered Components

Increased corrosion risk

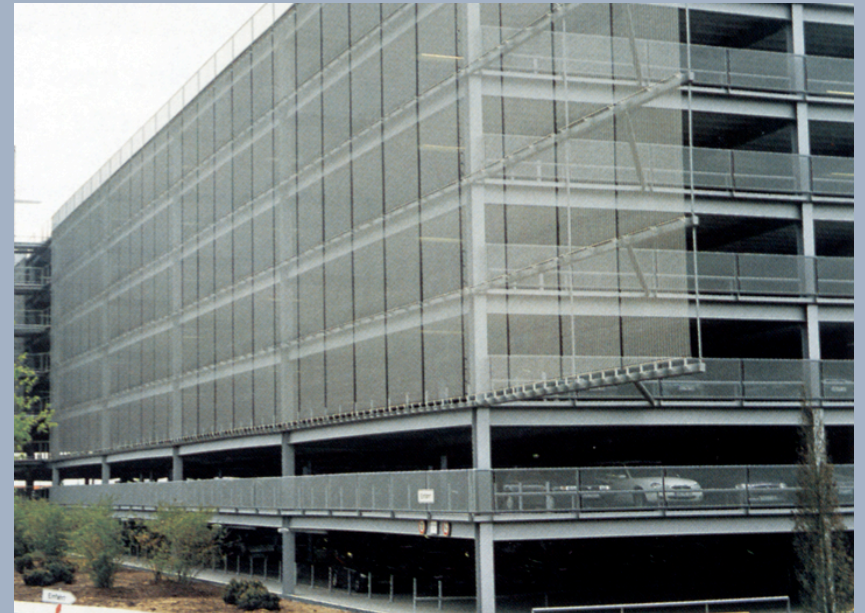
Sites for Crevice Corrosion

If the design will be exposed to salt (chlorides) and moisture, avoid crevices or seal them to prevent corrosion

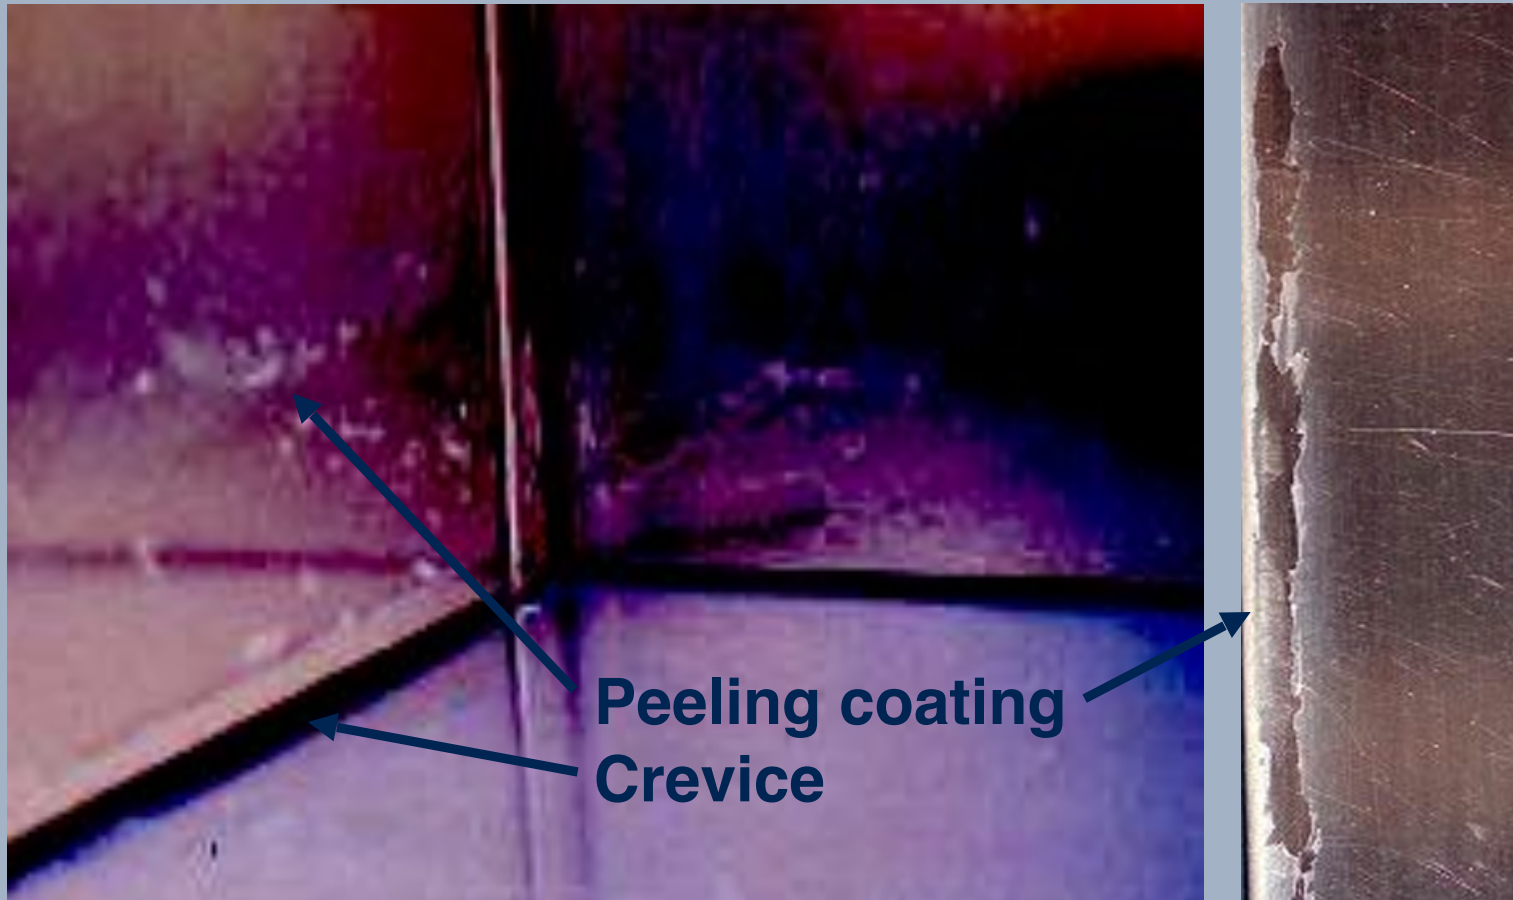
- Coatings are not necessary, require regular replacement, and can cause corrosion
- Using the right stainless steel is more cost effective

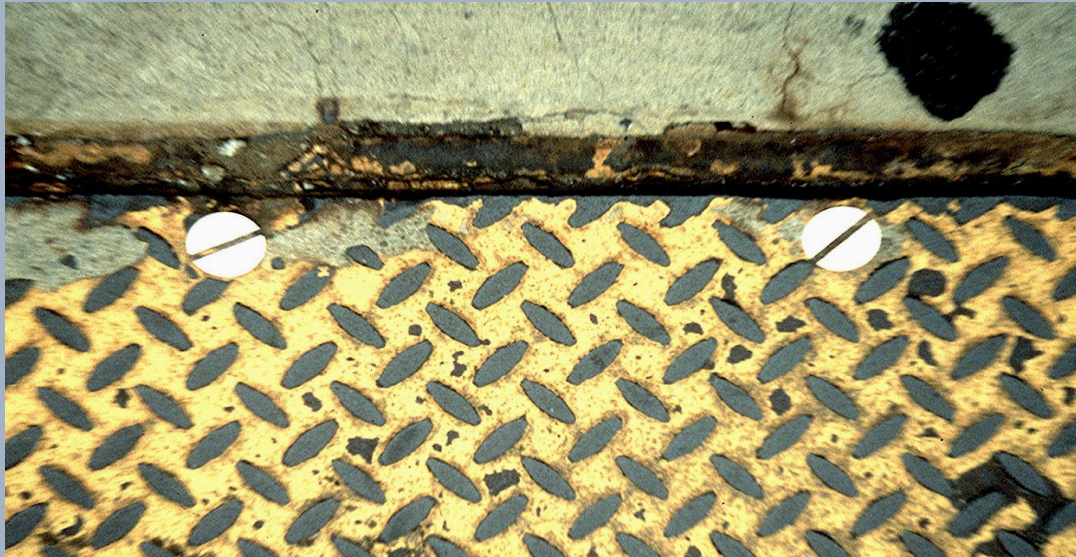
- Stainless steel fasteners in carbon steel cover
- Good ratio = no impact on corrosion rate
- Galvanized fasteners in stainless steel
- Bad ratio = rapid corrosion

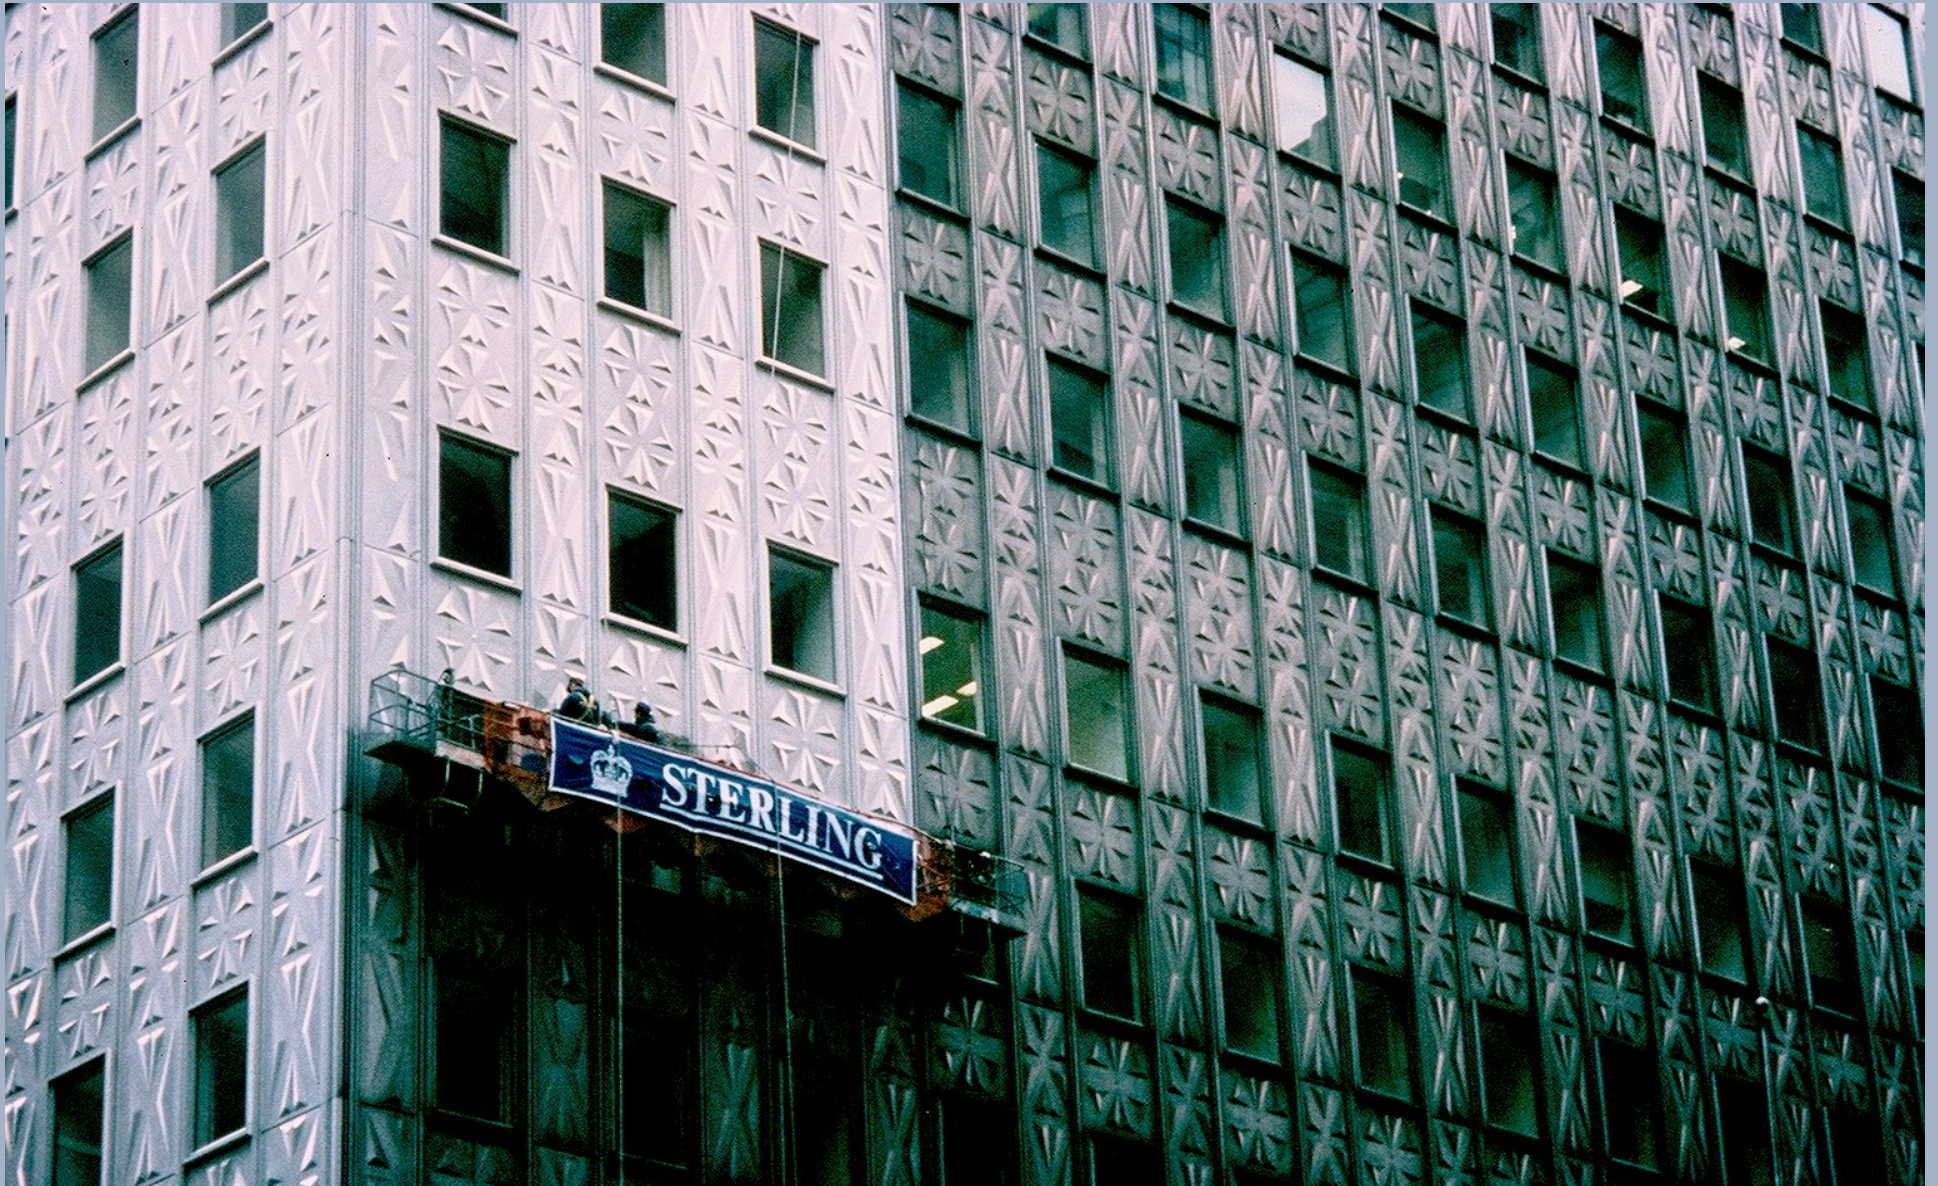
150 East 42nd Street, New York City
Cleaned for the first time after 30 years of service

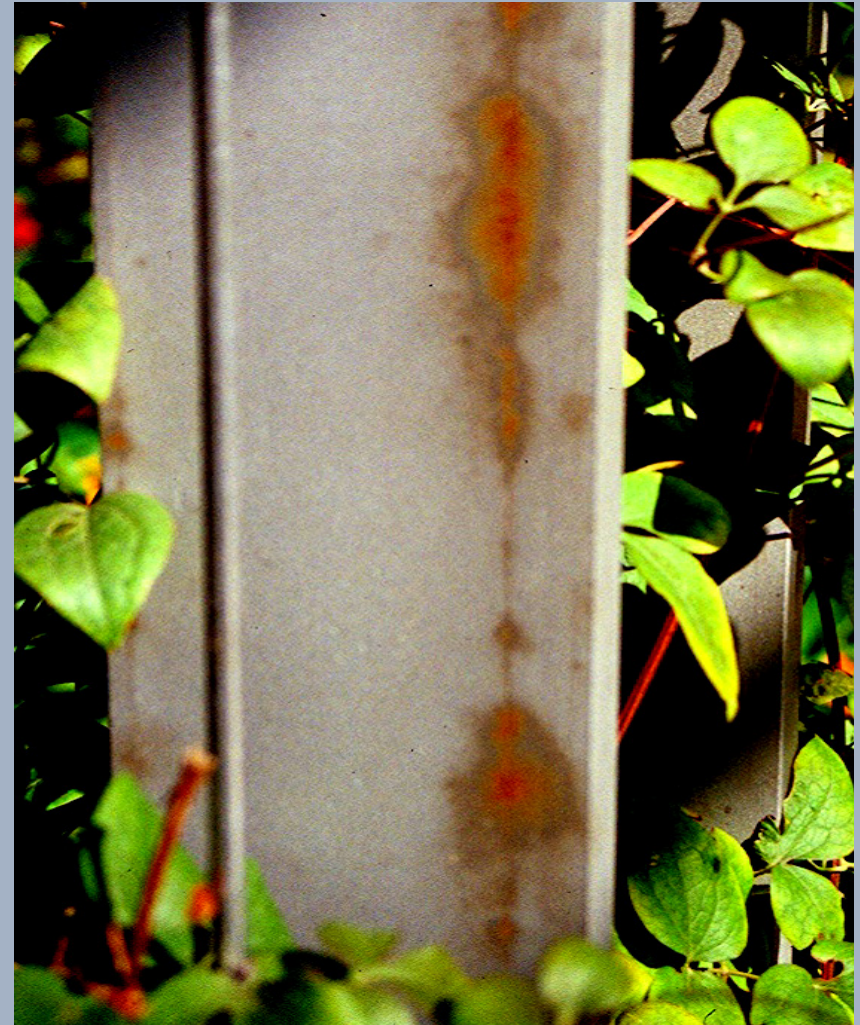
Embedded Iron Corrosion

- Remove by
 - Mechanical cleaning
 - Chemical cleaning (“Passivation”)
- Confirm cleaning by test to
 - ASTM A 967, Chemical Passivation Treatments for Stainless Steel Parts

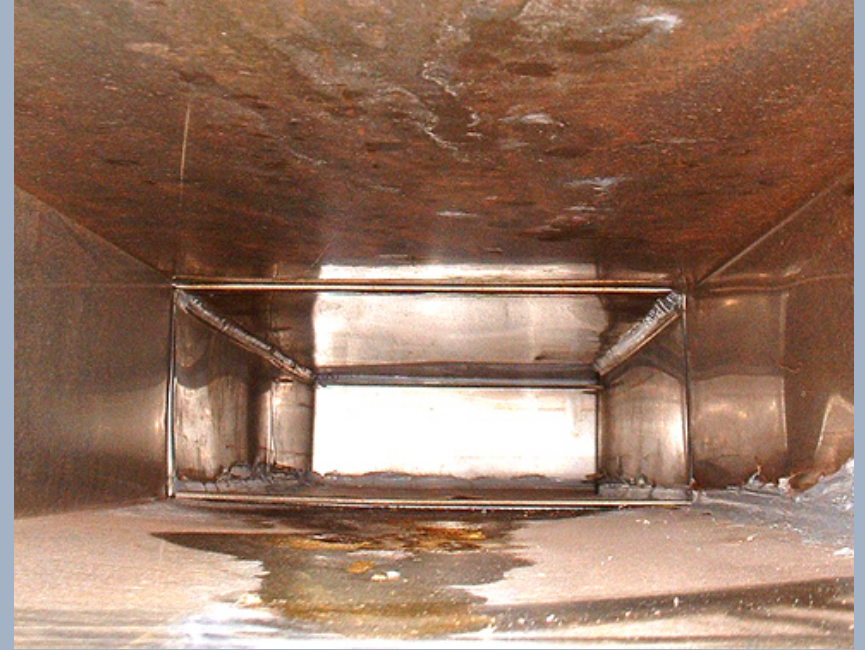
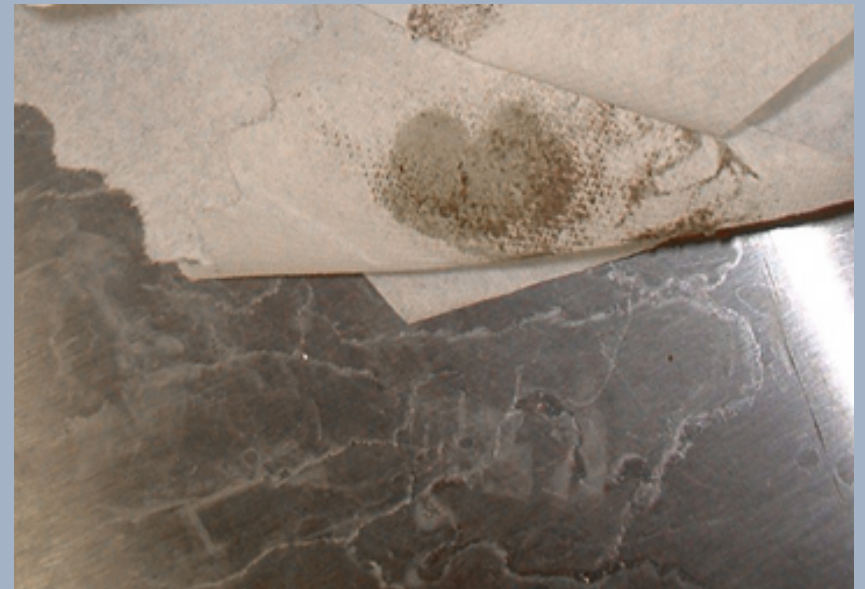
Muriatic Acid Corrosion

- Tile, stone, masonry or concrete are sometimes cleaned with Muriatic (hydrochloric) acid
- Muriatic acid is very corrosive to stainless steel!
- Avoid Muriatic acid containing cleaners
- Use citric acid or other non-corrosive cleaners

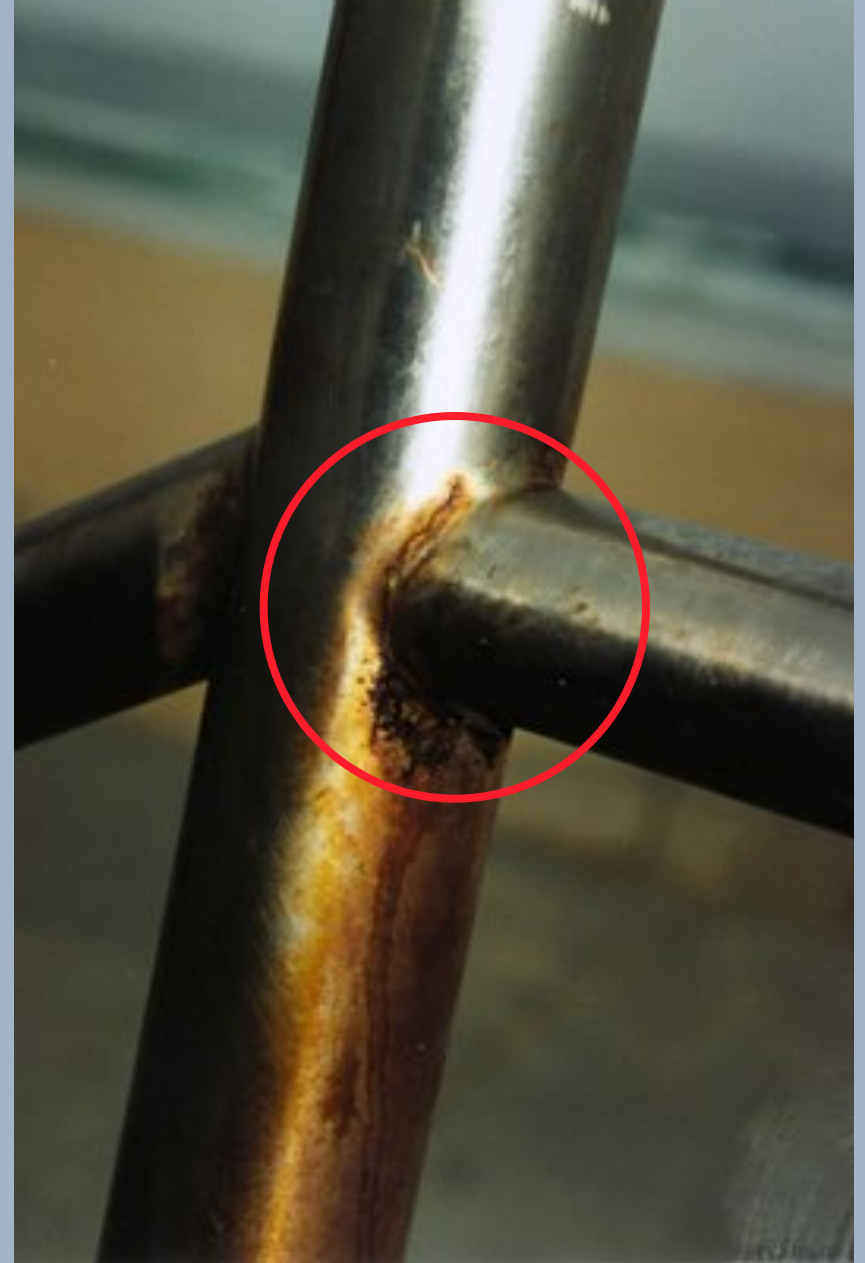
Removing Welding Heat Tint

- Mechanical methods
 - Grinding
 - Abrasive blasting
- Chemical methods
 - Pickle paste
 - Pickling
